SELECT SEAM NARROW BATTEN

CLIP INFORMATION

SSNB-02

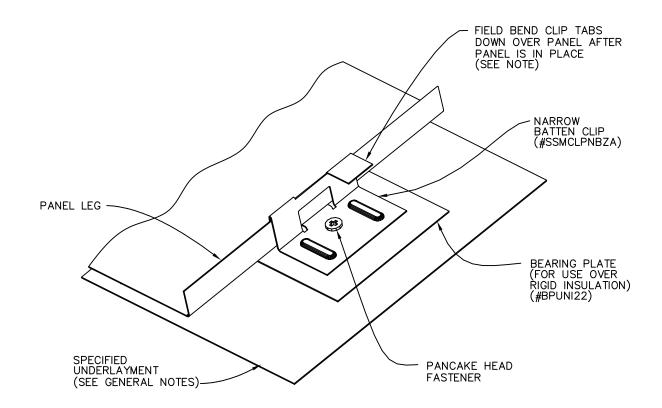
NOTE:

THE TABS OF A CLIP UP AFTER THEY HAVE BENT DOWN INTO PLACE, THE CLIP MUST BE REPLACED TO PREVENT CLIP FAILURE
